FOIA request #EPA-R6-2014-002460

**SUBJECT:** Transmittal Memo – Compliance Monitoring Report

**FACILITY NAME:** Louisiana Land & Water Co Inc – Cooper Lake/Lakeview  
Subdivision STP

### **NPDES Inspection Report Information**

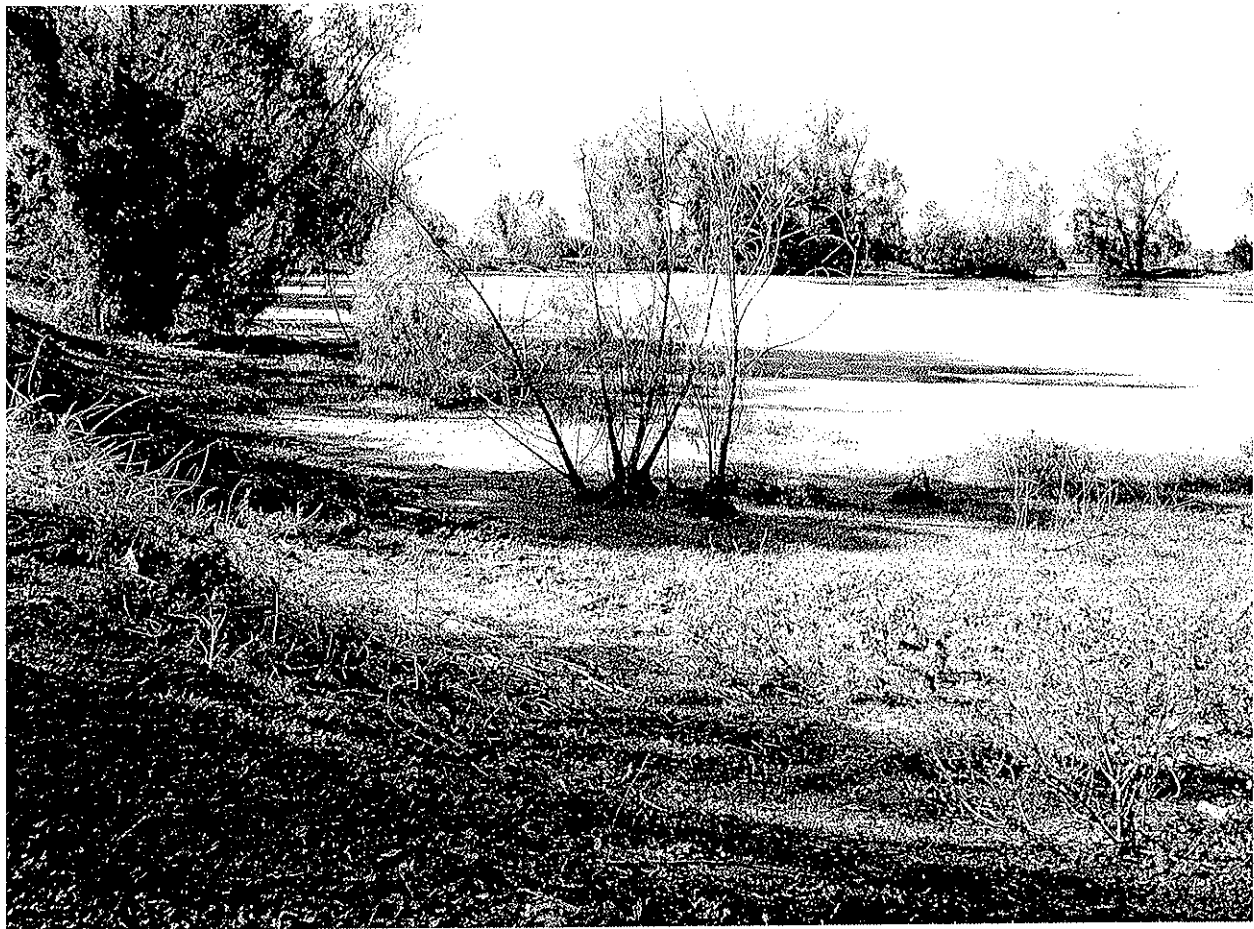
Photo: 1

**Subject:** Overview of oxidation pond with vegetative growth. Note very large mature trees.

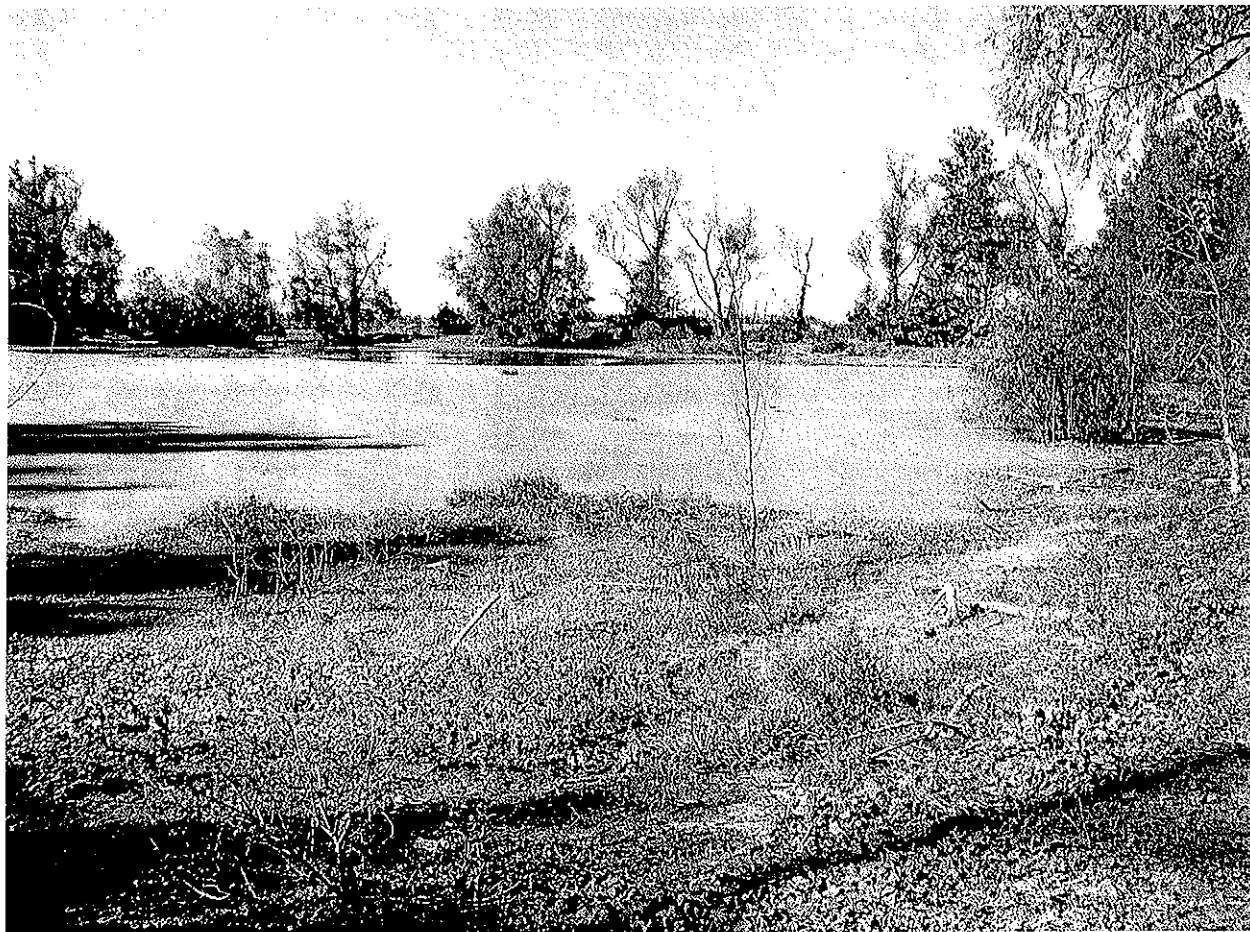
Photo: 2

**Subject:** Panned shot of oxidation pond. Note large surface blanket of duck weed on pond surface.

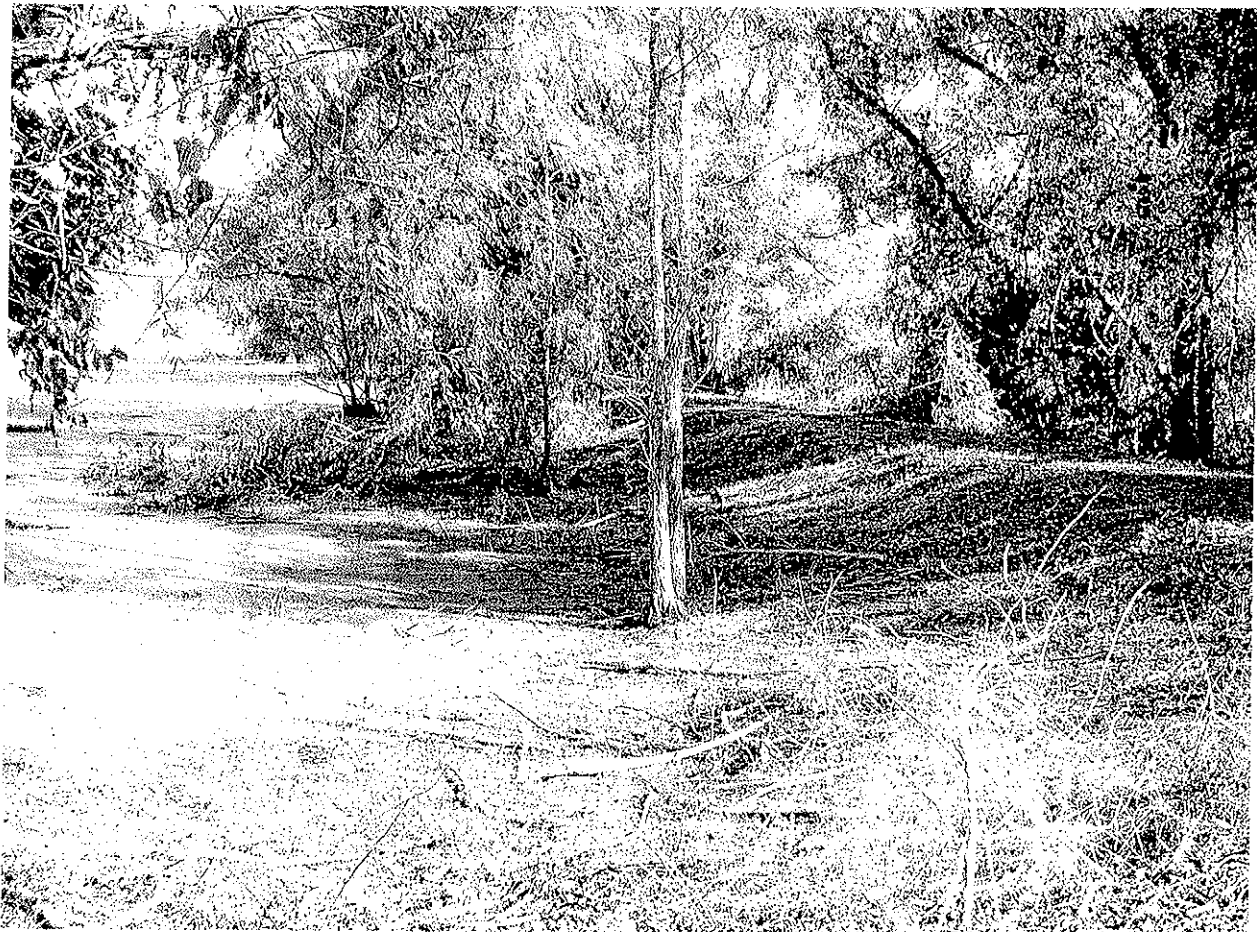
Photo: 3

**Subject:** Trees growing inside of berm wall.

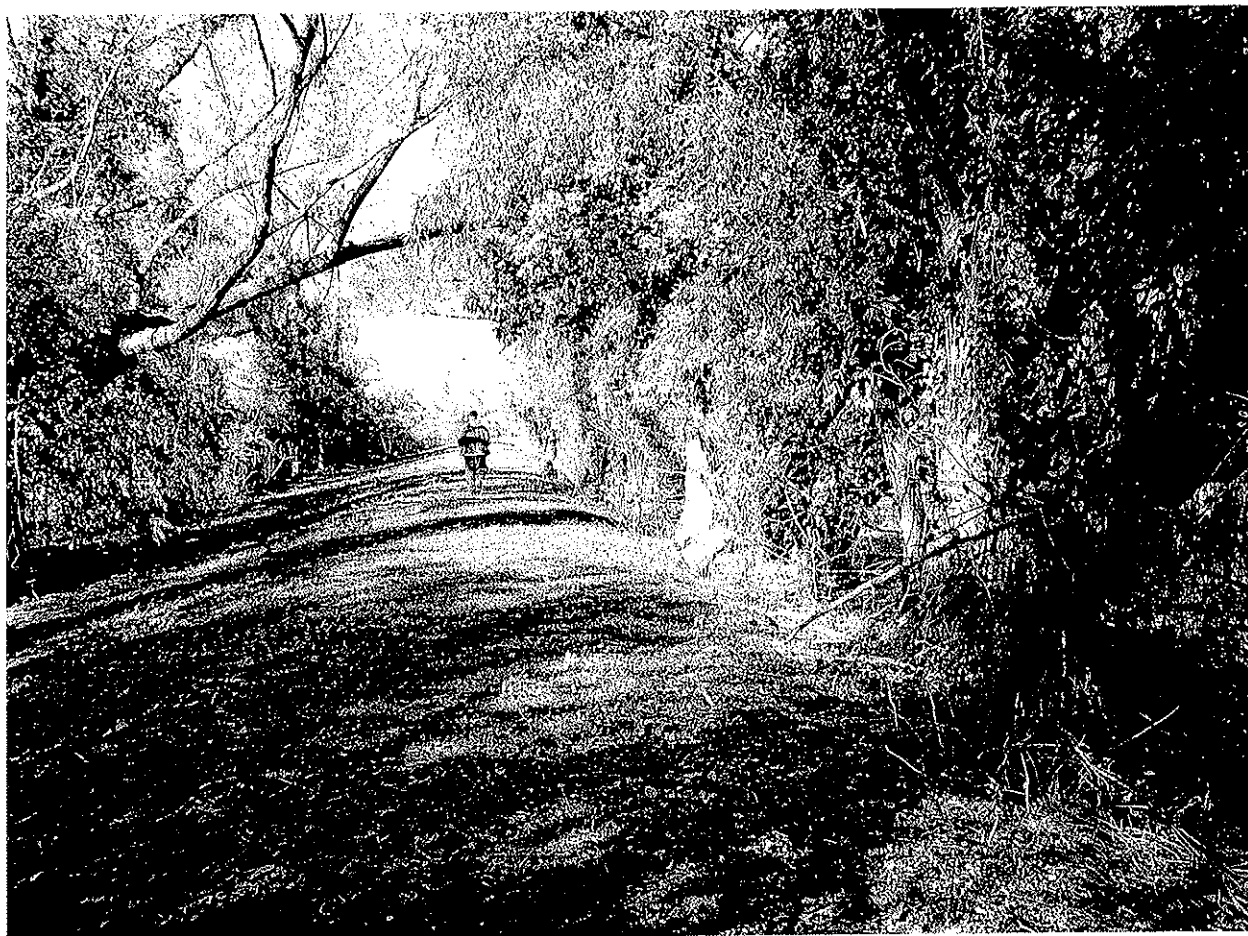
Photo: 4

**Subject:** Treeline growing on inside berm wall.

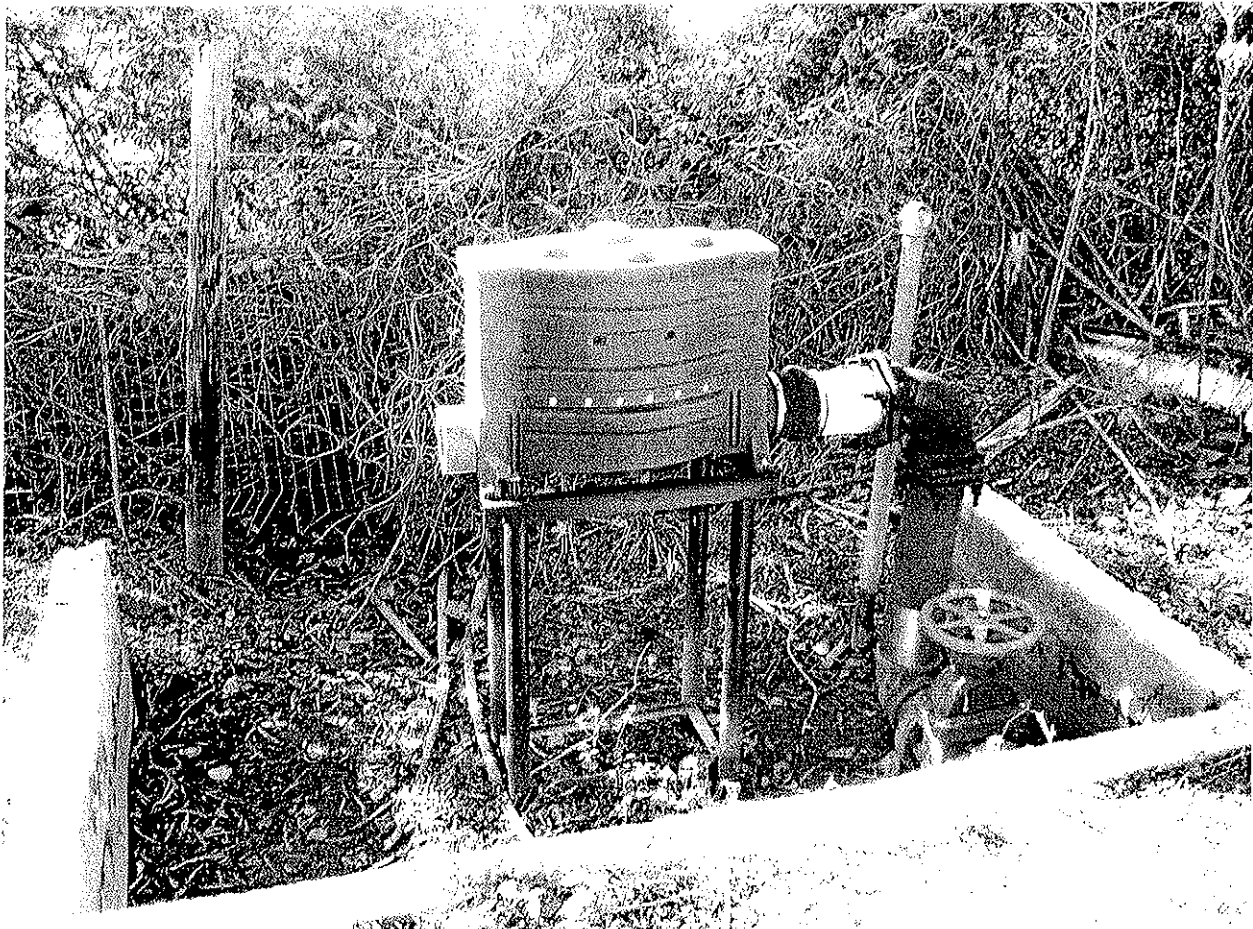
Photo: 5

**Subject:** Stack-feed chlorinator on metal stand for treatment of effluent discharge from pond. Pond was not discharging at time of inspection. No concrete contact chamber follows the chlorinator as required to meet the minimum detention time for proper disinfection.

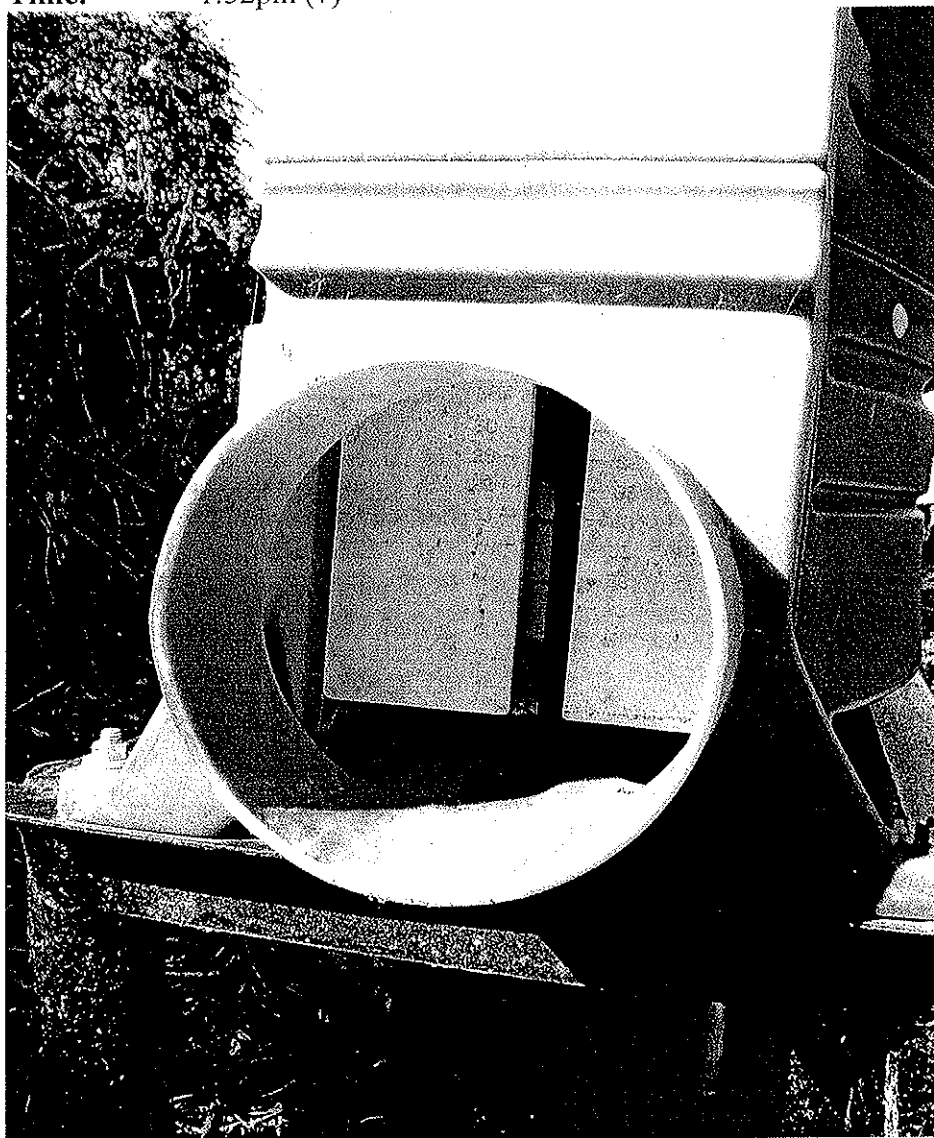
Photo: 6

**Subject:** Discharge opening in stack-feed chlorinator. Chlorine tabs and evidence of a prior discharge are visible.

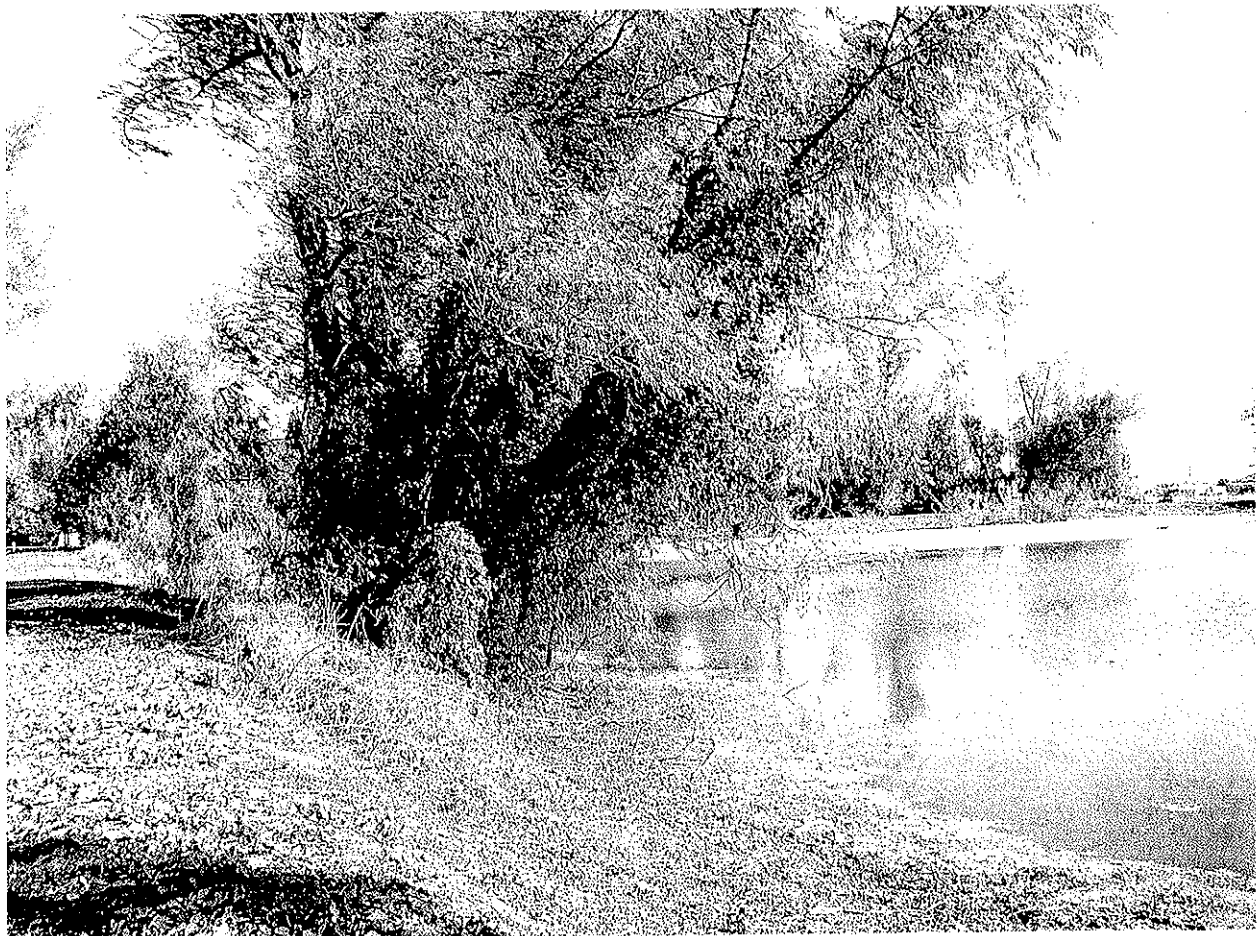
Photo: 8

**Subject:** More adult trees growing inside of oxidation ponds berm walls.

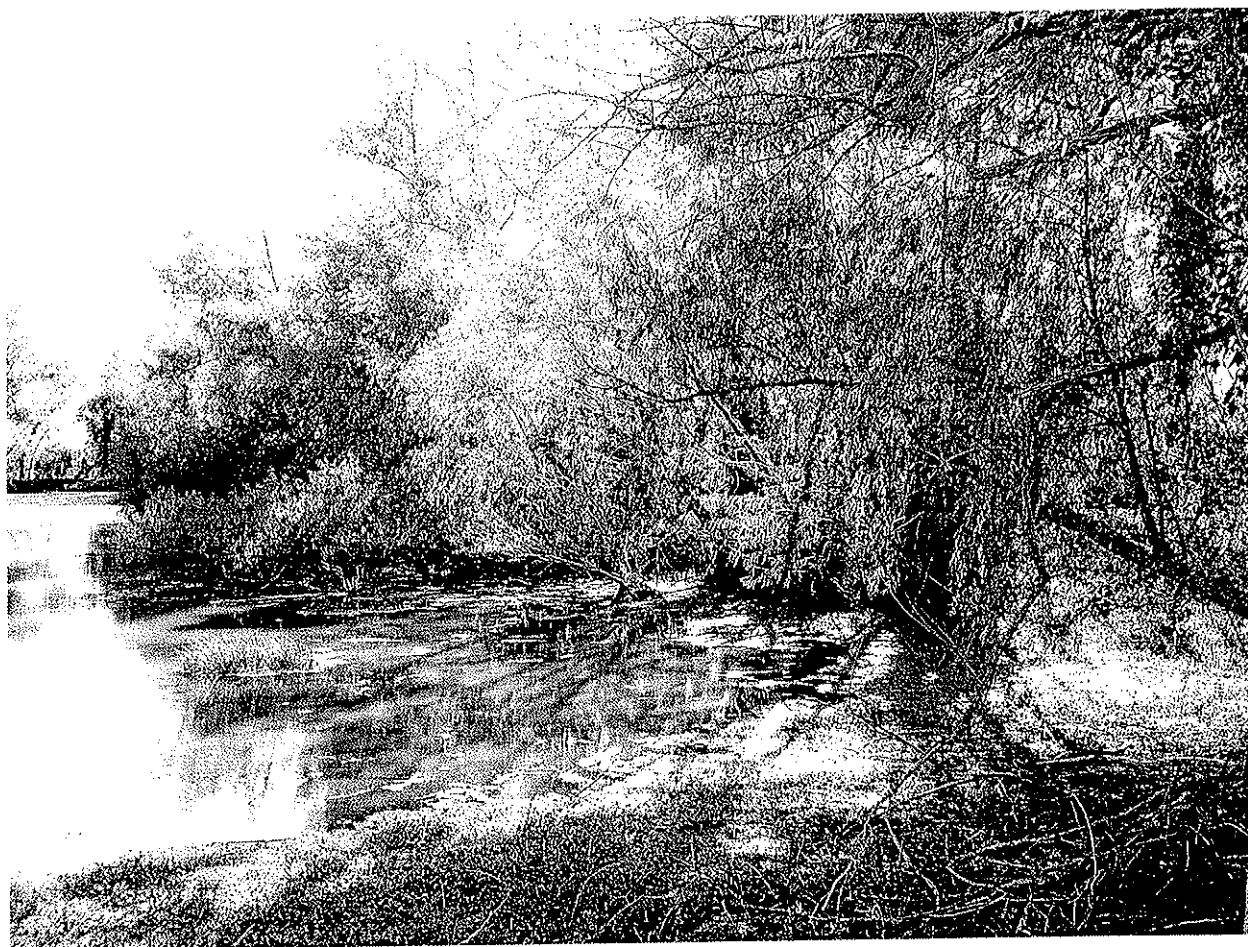
Photo: 9

**Subject:** Large copse of trees growing inside of oxidation pond's berm walls.

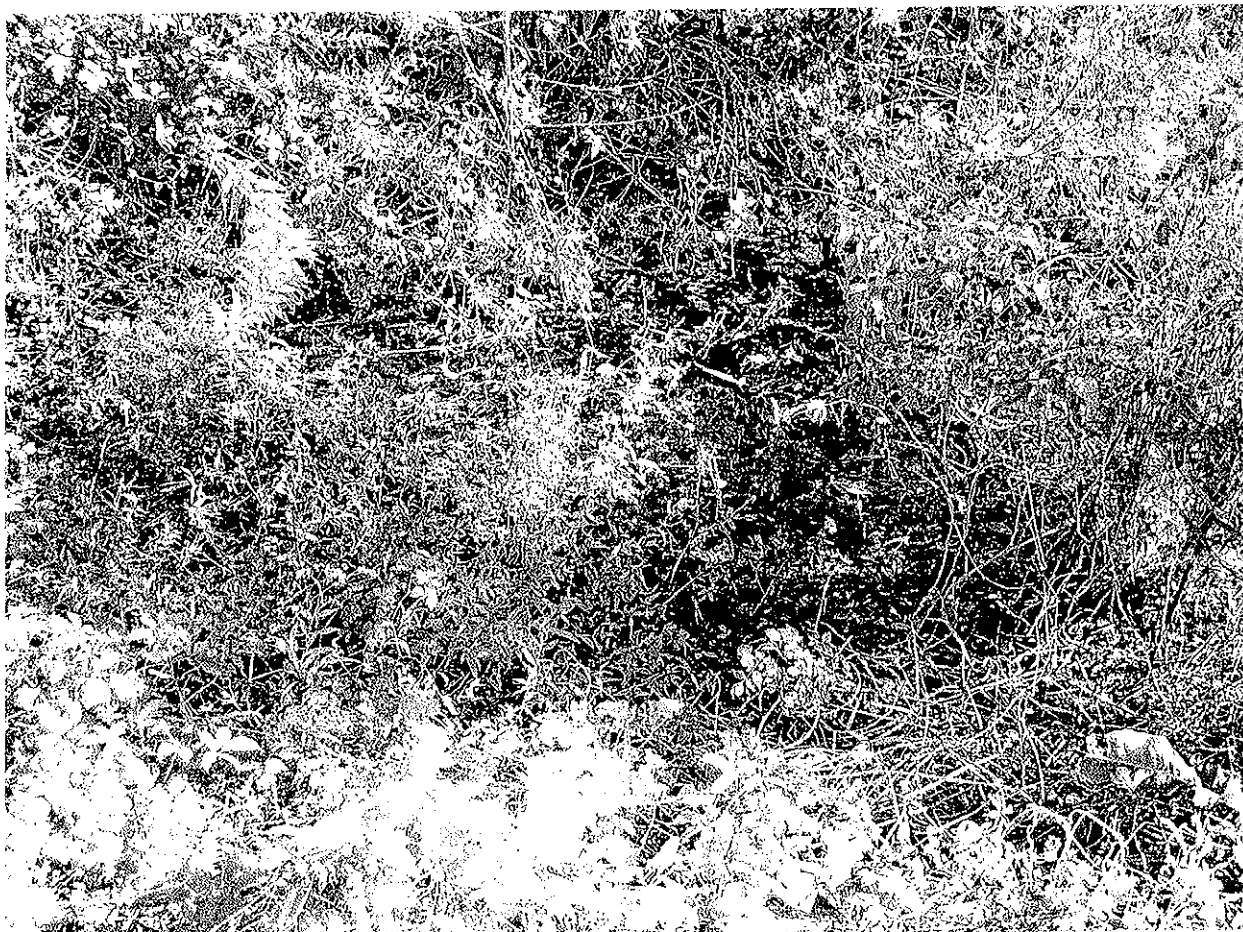
Photo: 10

**Subject:** Drainage ditch holding water outside of fenced pond area. The ditch is situated between the adjacent field and the fence.

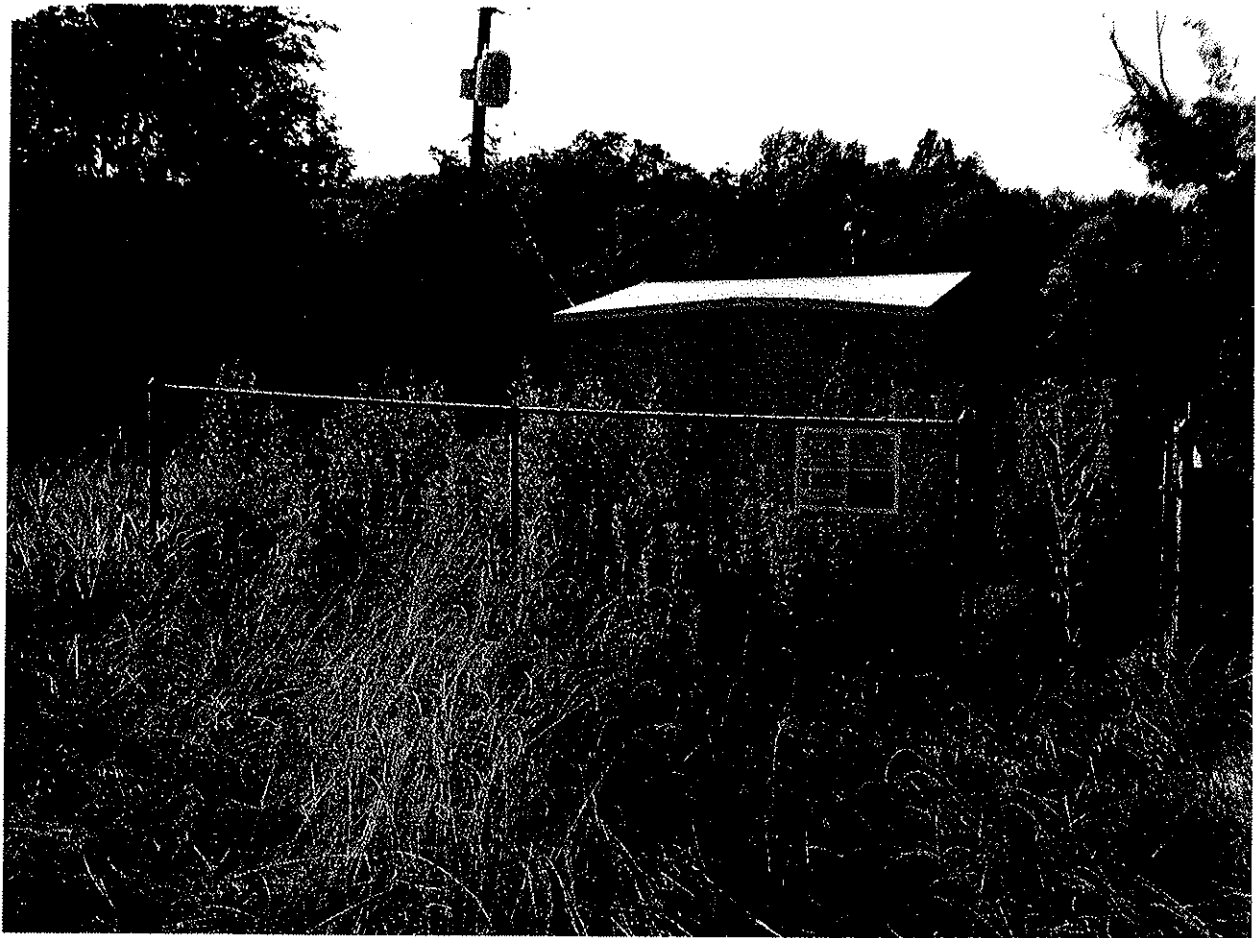
**Subject:** Overgrown storage area

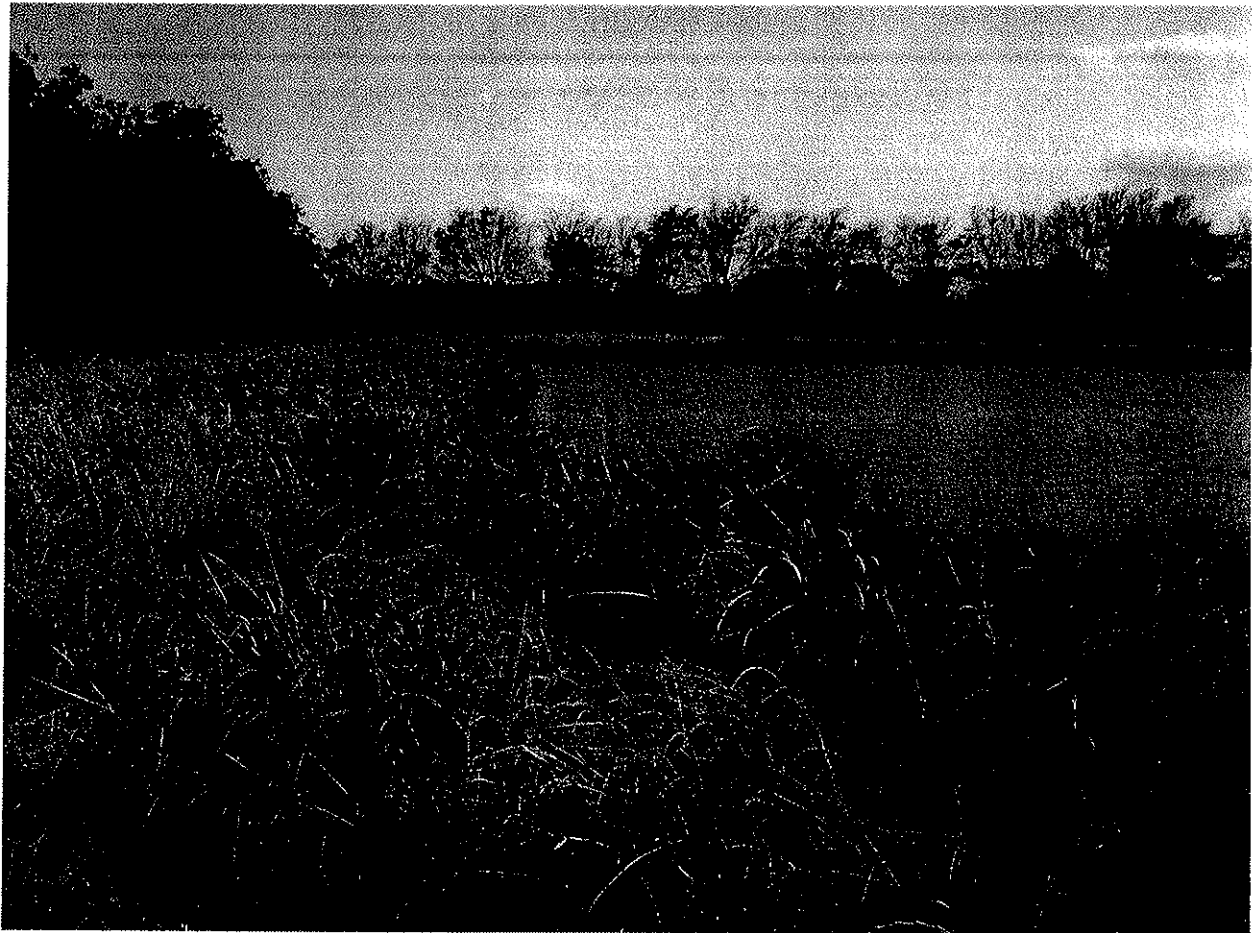
**Subject:** Overgrown pond bank

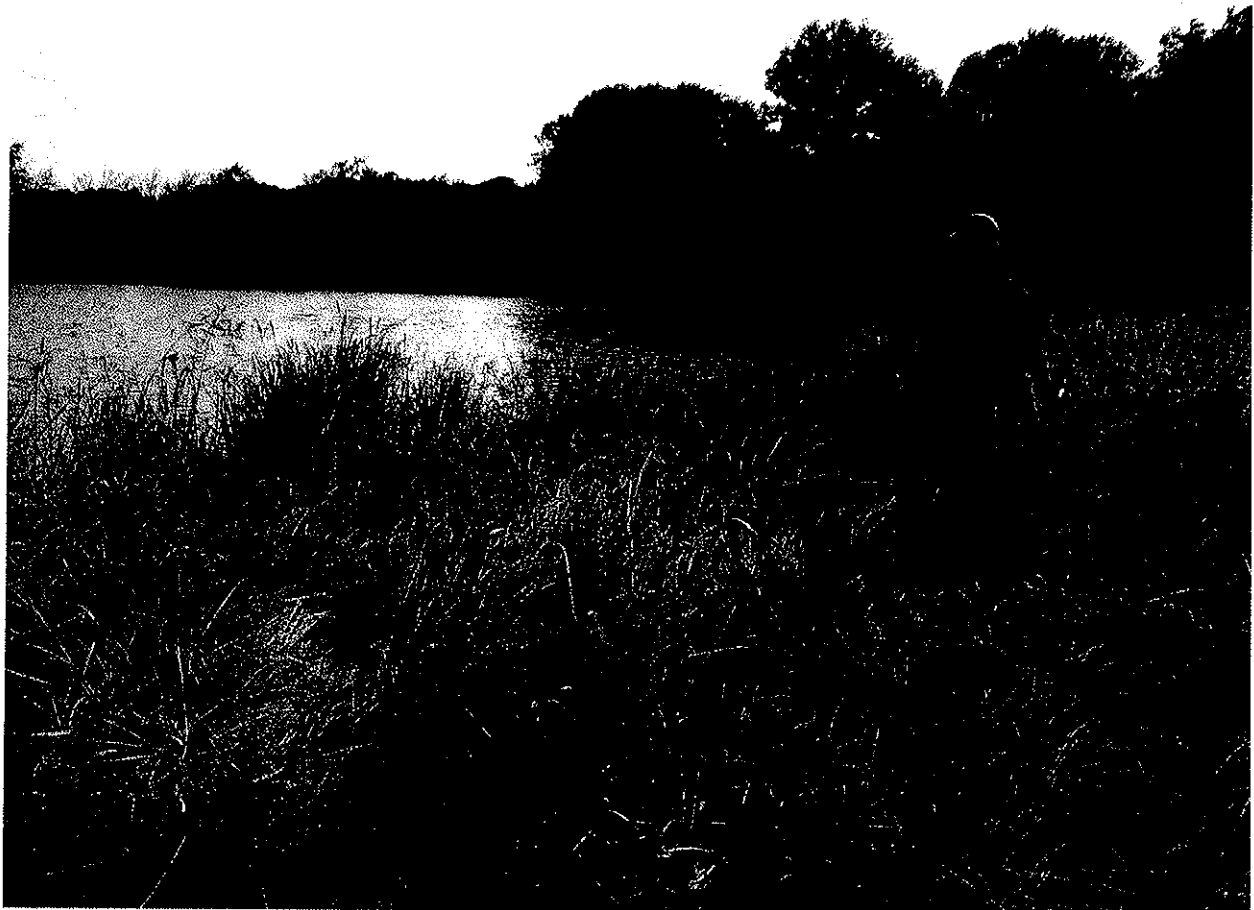
**Subject:** Overgrown pond bank

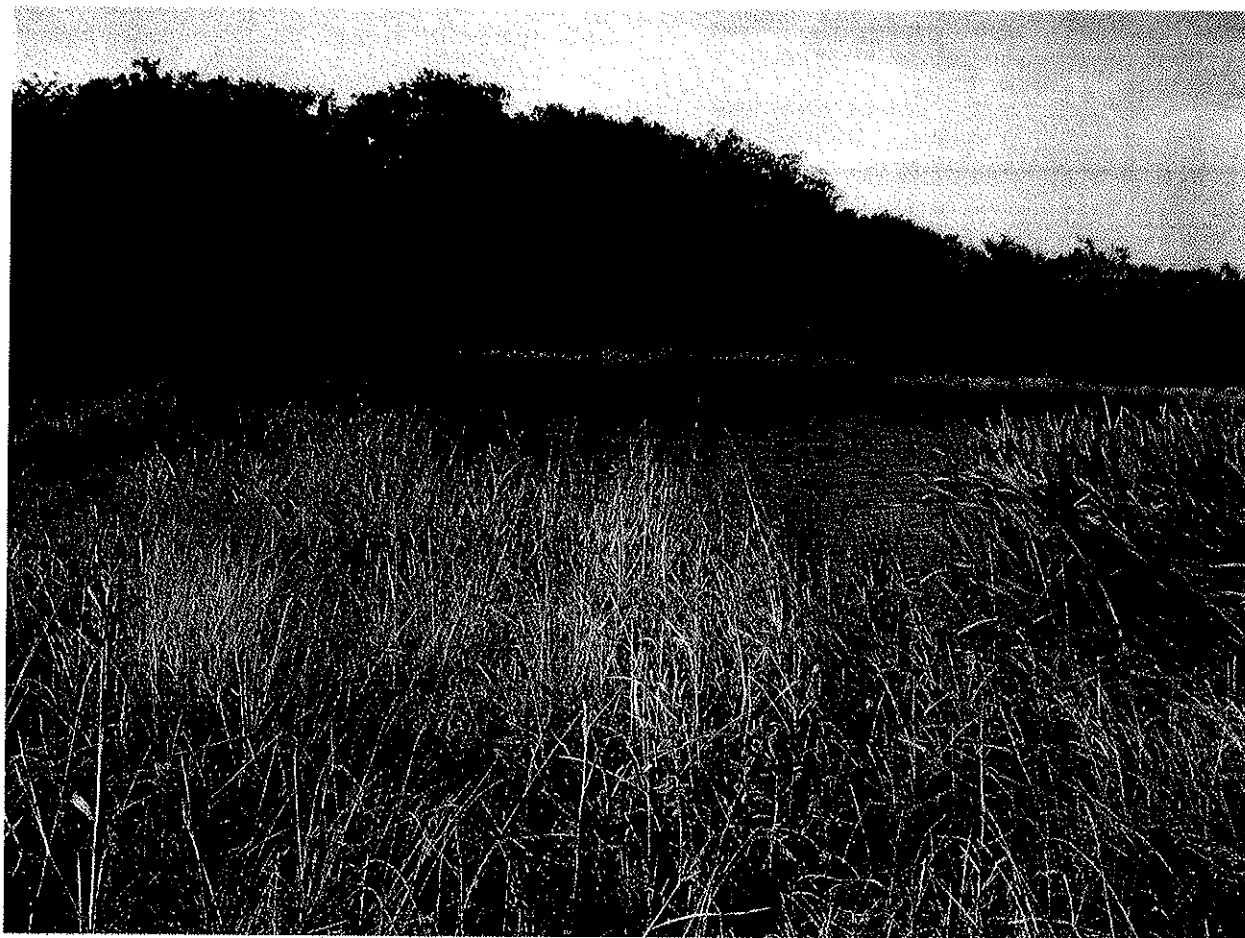
**Subject:** Overgrown pond bank
